By Paul Weissler, MACS Senior Technical Correspondent

May 2014

WHAT PARTS ARE LEFT?

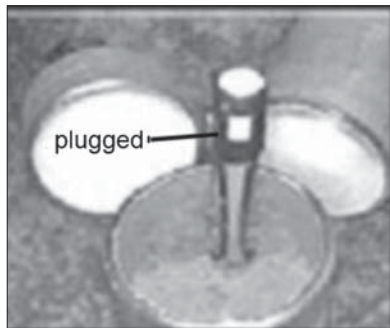
Number one was traditionally a restricted hose; almost a sure thing when a compressor failed. Very close to that was compressor debris (often from piston rings) on the screen of an orifice tube or expansion valve, and these days, with micro-channel condensers, debris in the condenser itself. Even with the smaller desiccant bags, receiver / driers and "modulators," a collapsed and / or split bag can deposit desiccant and debris all throughout the high-pressure side of the system (typically in the con-

denser, orifice tube, or expansion valve). See Figures 1, 2. Occasionally, as we've mentioned, a suction side hose will collapse internally; doesn't happen often, but it happens. More on that in the June issue of MACS Service Reports.

Figure 1: Collapse of drier and internal separation of desiccant produces restriction.

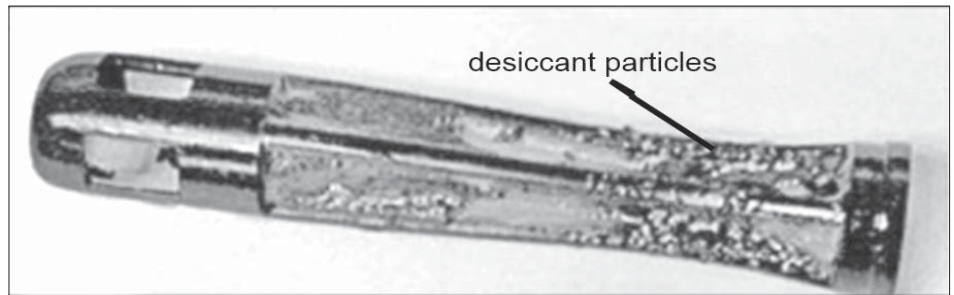
Figure 2: Cutaway of drier shows accumulation of desiccant particles to restrict refrigerant flow.

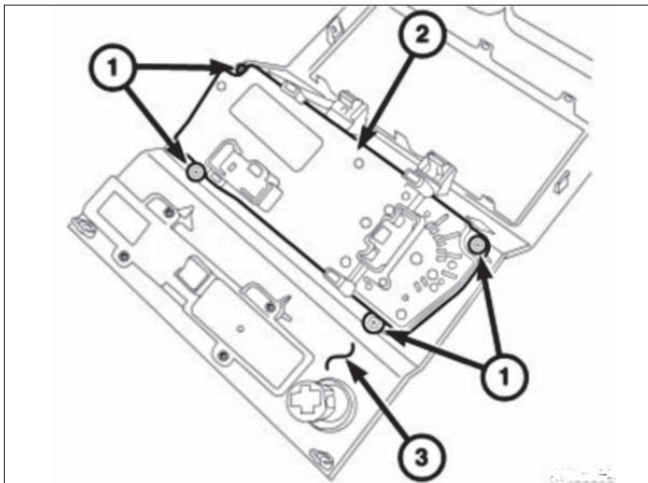
Figure 3: HVAC control module is built into control head. Remove bezel (3), then four retaining screws (1) and module (2) comes out.

Yes, it ends with a reflash, but it starts with a new HVAC control module (Figure 3). This applies only to 2007 Nitros, which tells you that the factory fixed this problem on the assembly line for the next model year. If the build date is May 30, 2008 and later (which would apply to late 2008 models), just recover and recharge to the 18 oz spec. If the build date precedes May 30, 2008, and you see the reflash listed (operation 24-50-09-90), then it's already been done. You may have to replace the HVAC module, and because that's not pocket change, it has to be last on the to-do list.

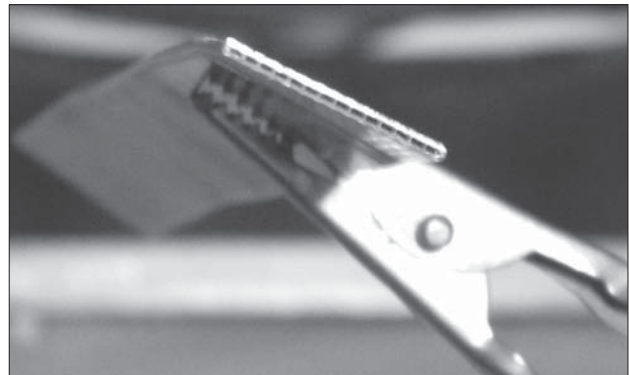
was debris in the condenser, and that the first flushing didn't do the job, but a repeat did solve the problem. **To be honest, we're not crazy about flushing condensers, although many shops swear by it, particularly if they're back-flushing with a pulsating flusher, like the Hecat unit (also sold under its brand by Gates).** When we had 6 mm diameter passages in the tubes of condensers, back-flushing was definitely worth a try if you were looking to keep the ticket down to something that would not give the customer an angina-like reaction. It's probably still worth trying on older cars, where the tubes are somewhere in the visible category. Some of today's tubing channels are so tiny you need a magnifying glass to see they aren't a solid strip of aluminum (Figures 4, 5). But that's your call. ■

Figure 4: Close-up of end view of new condenser tubing. Although tubing looks like a solid strip of aluminum, under magnification you can see the refrigerant vapor flow paths.

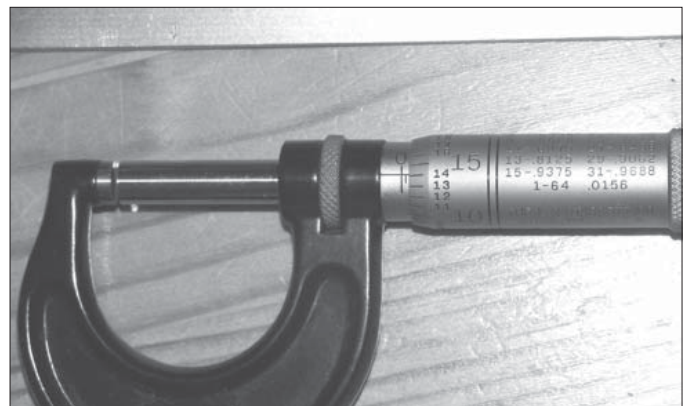
Figure 5: We measured overall thickness of the tubing with a micrometer. It's just .065-in including the inner and outer walls of the tubing, which equals 1.66 mm, or just over a quarter of the diameter of the passage in a 6 mm condenser tube of not too long ago.
